SIO Shipyard Representative Bi-Weekly Progress Report		
<b>Project: AGOR 28</b>	<b>Contract No.: N00014-12-C-0305</b>	<b>Shipyard: Dakota Creek Industries</b>
<b>Prepared by:</b> Paul D. Bueren Scripps Institution of Oceanography (SIO) 297 Rosecrans St. San Diego, CA 98106	<b>Date:</b> 18 June 2016	<b>Program Officer:</b> Robert (Tim) Schnoor Office of Naval Research 875 Randolph St ONR 321 Arlington, VA 22203-1995
<b>Distribution Statement A:</b> Approved for public release; distribution unlimited.		<b>Report No. A002.100</b>

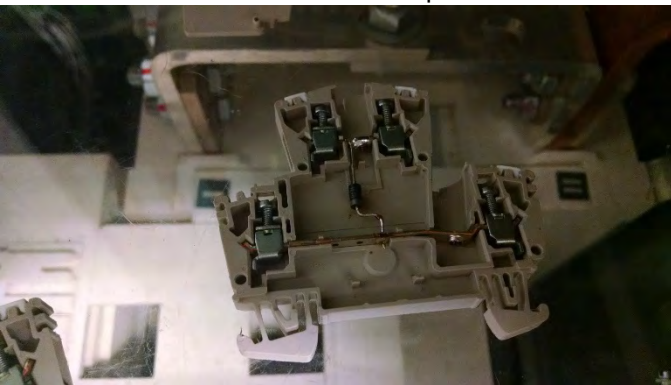
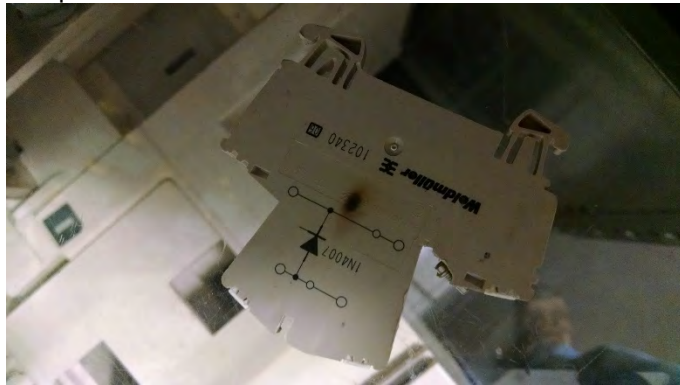
- Blue Drive Starboard – 24-volt system failed due to shorted temperature sensor at the Tunnel Thruster motor. A small rectifier was found to have failed in the terminal block found in the Active Front End (AFE). The 1n4007 Rectifier is readily available for 16-cents. Will order additional diodes for spares. Siemens to make repairs.

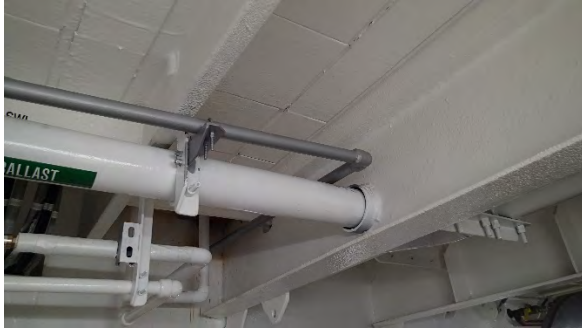
- Sonar Self-Noise Sea Trial Completed
- Fire Main Sea Chest Vent – DCI relocate Vent terminus has from the winch room overhead to the main deck.

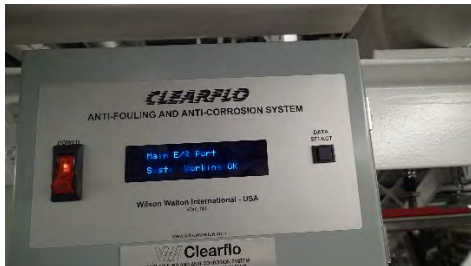
- ClearFlo Anti-Fouling Anti-Corrosion System – Installation complete and operational.

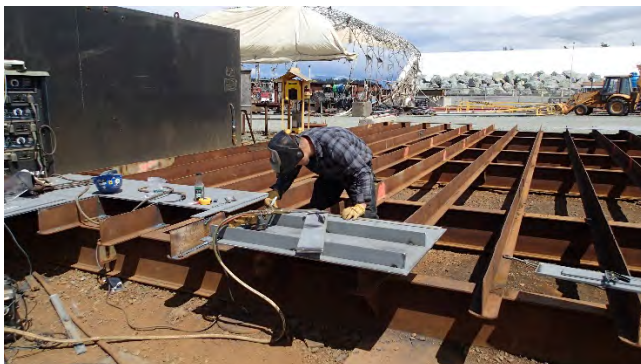
- Uncontaminated Sea Chest Relocation – Sea Chest and associated piping relocated, inspected and tested. Operational test performed during Sonar Self-Noise. No issues with getting a prime. A check valve and flanges are on order for installation into the suction line. This will be done by crew after delivery.
- Wet Lab Configuration Change – Double watertight door between Wet Lab and Staging Bay is on order. Prep work for installation of the soft-patch between the Wet Lab and working deck is ongoing.
- Pilot Station Bulwark Configuration Change – Yard is building the swinging door.

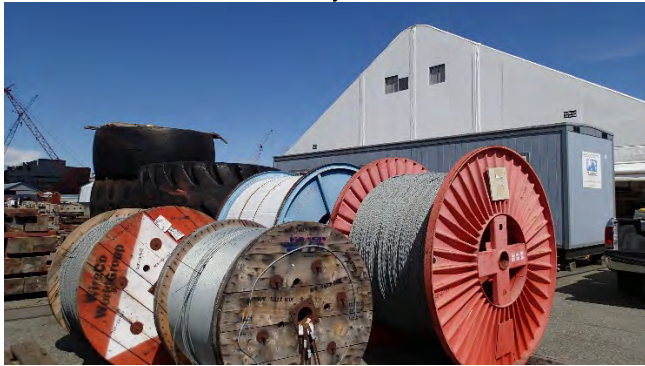
- Winch Wire – 4 spools of winch wire, the spooler and tensioner have are on site. Spooling to commence on 5 July.

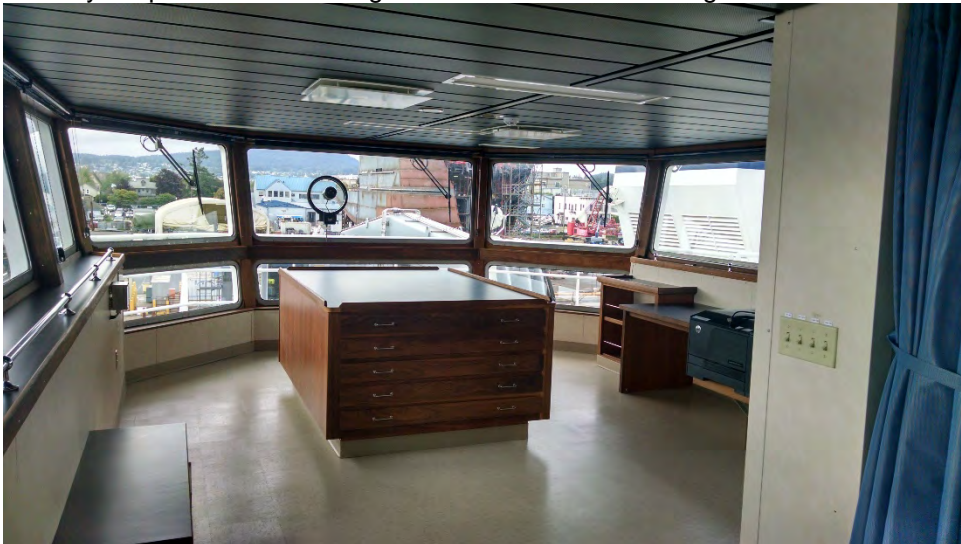
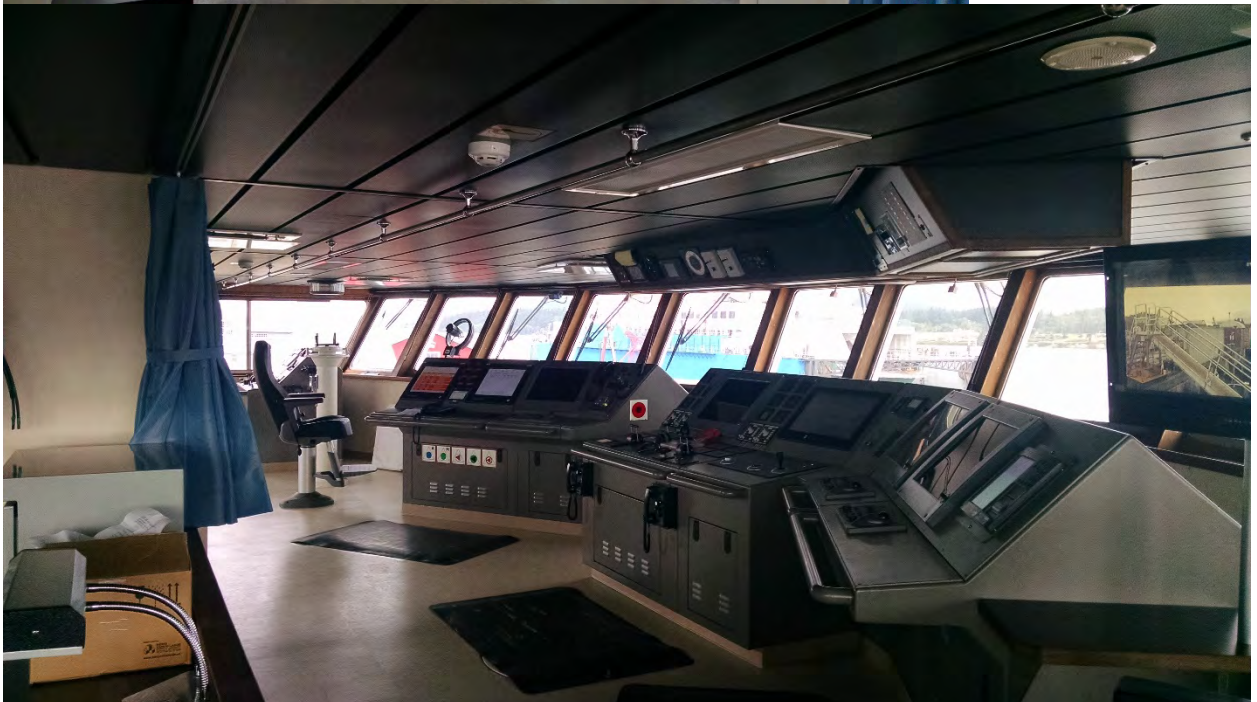
- Delivery Prep – DCI is removing bulkhead and floor coverings.

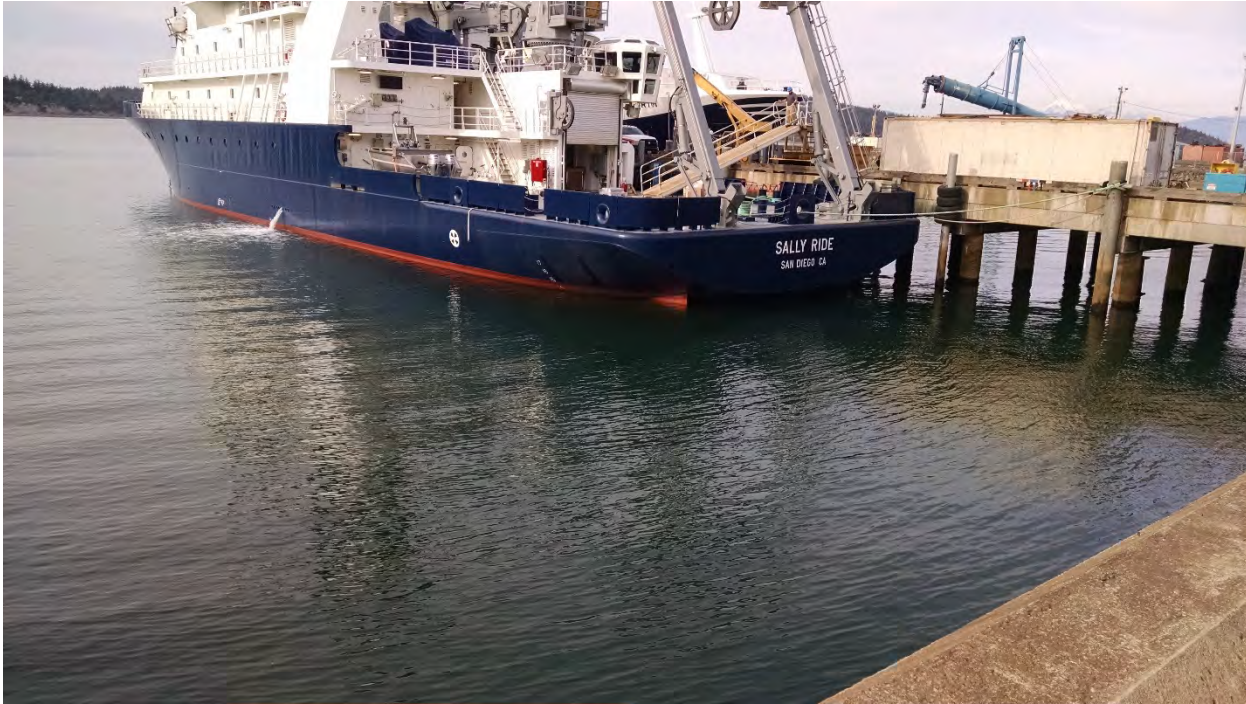
Not so much activity this past week. Galley Hood wash down system successfully demonstrated, (Trial Card) Electricians off working on Blue North. Oil changed in Main Engines, Set up for Coolant Change in E-Generator. Protective Coverings on decks being removed in preparation for Delivery.

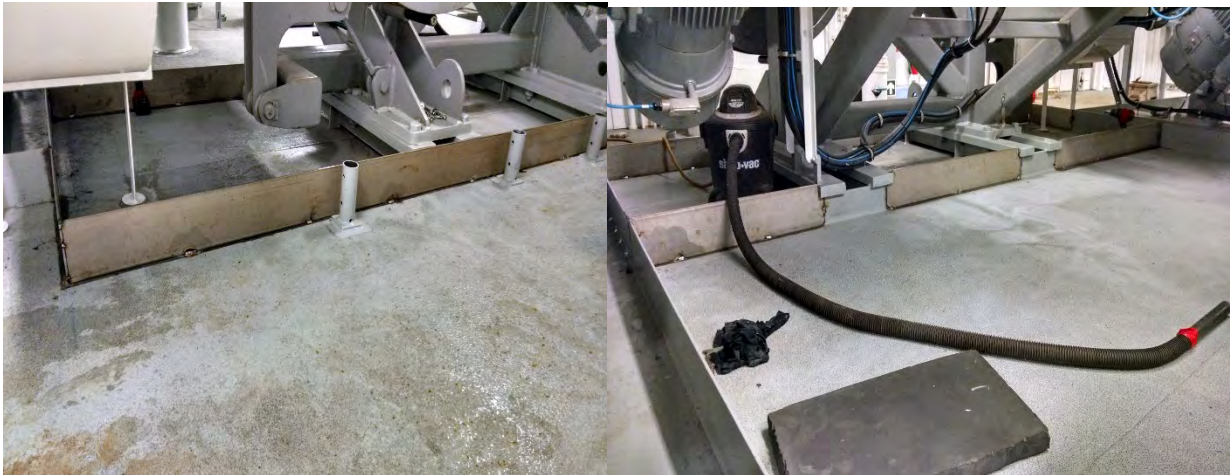
Other than painting Traction Winch Containment Configuration Change has been completed.

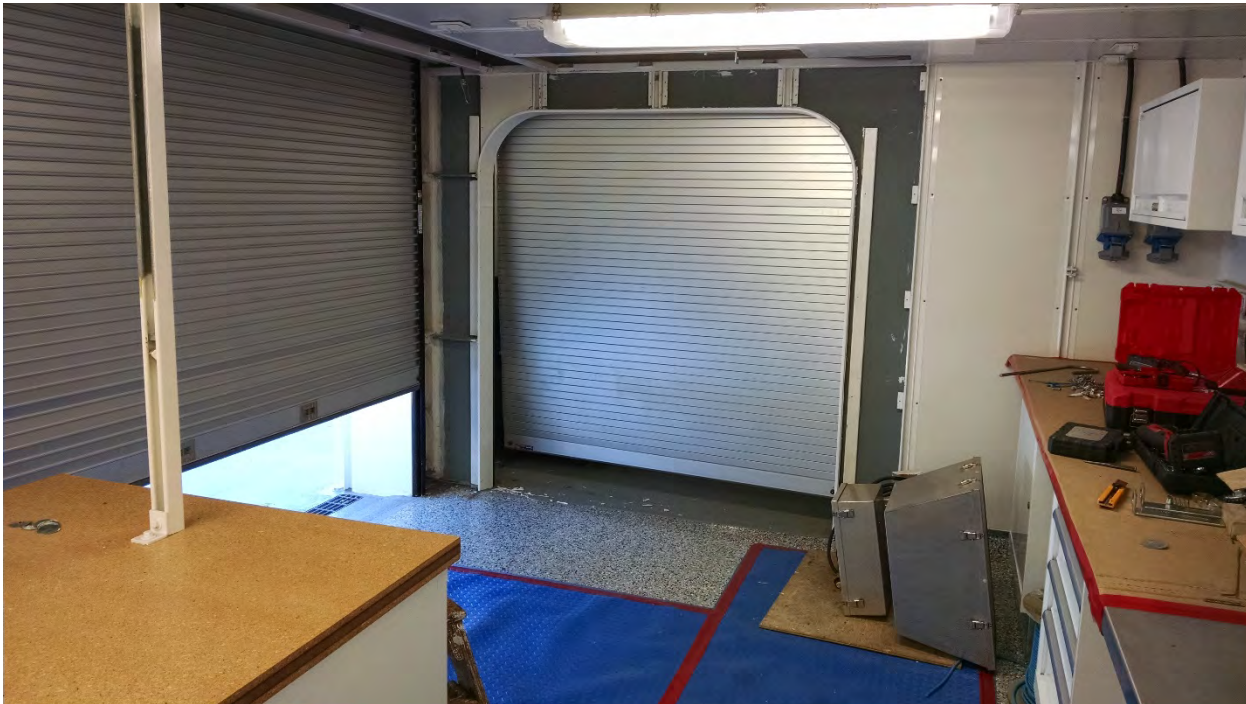
Trim and insulation removed around the wet lab and roller door to staging bay in preparation for soft patch and water tight hatch Configuration Change installation.

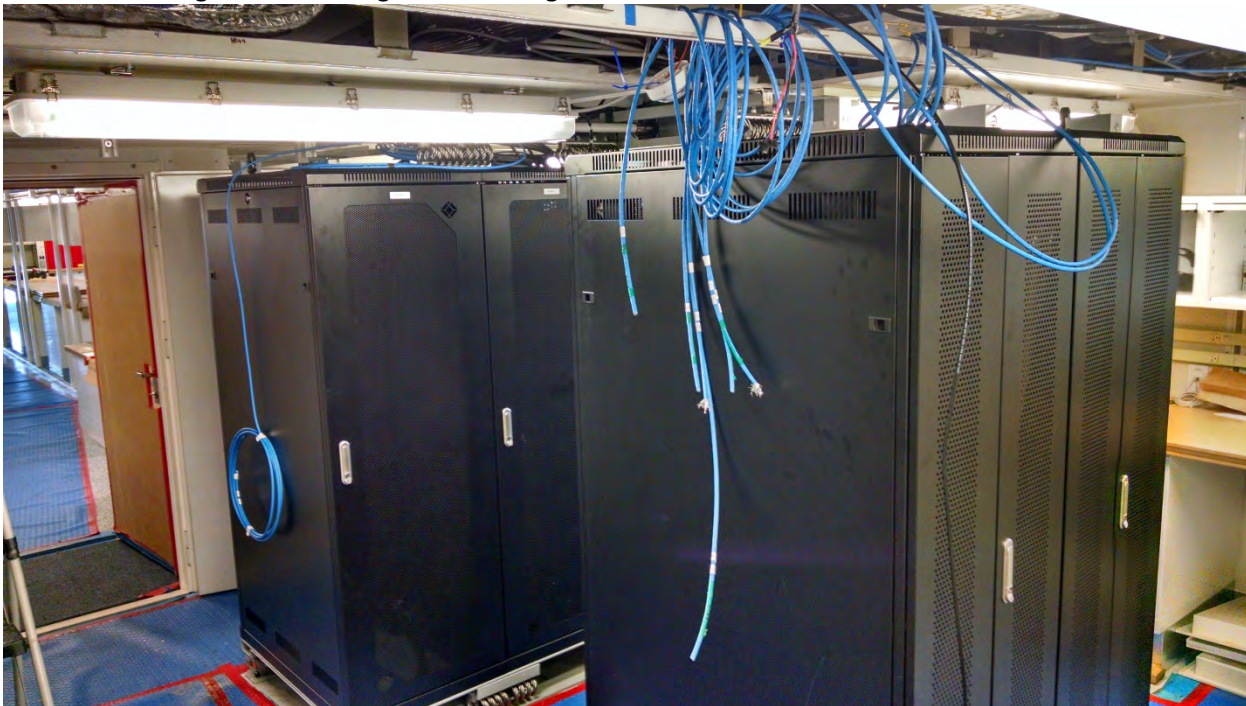
Computer racks in place and vibration isolation mts installed. Racks feel very stable.

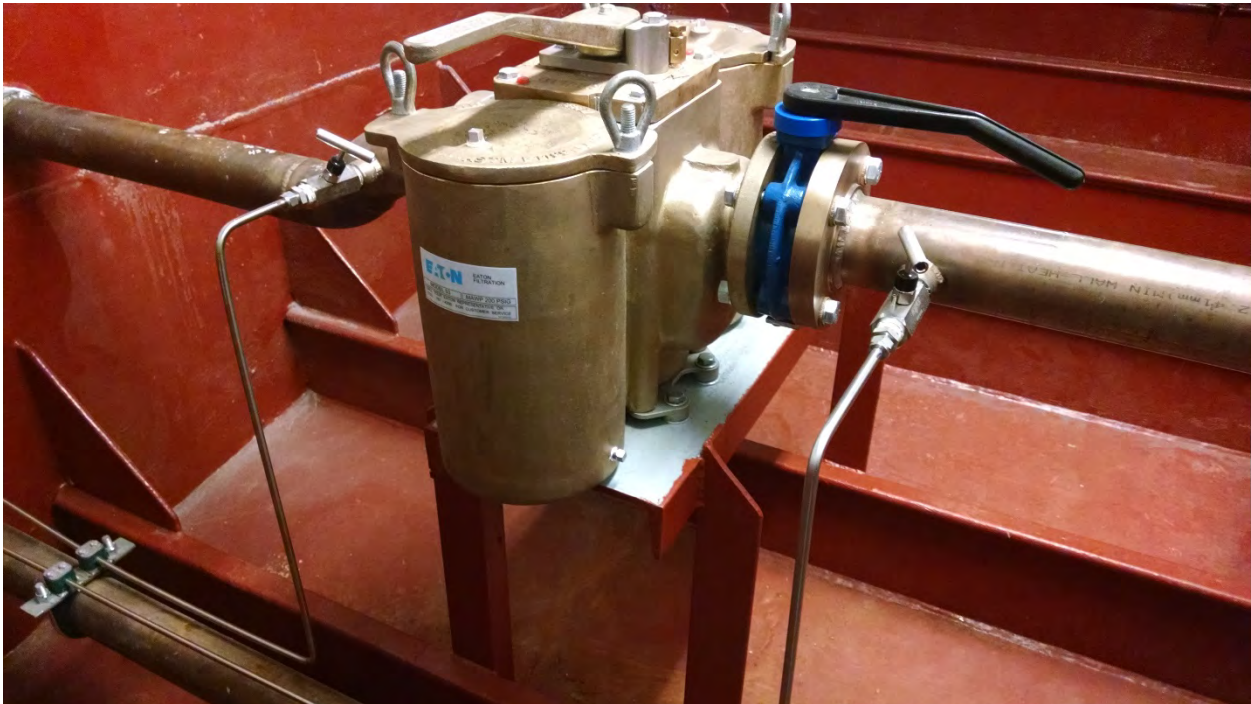
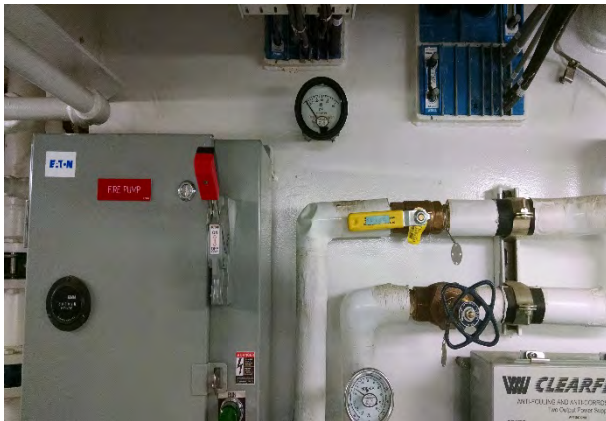
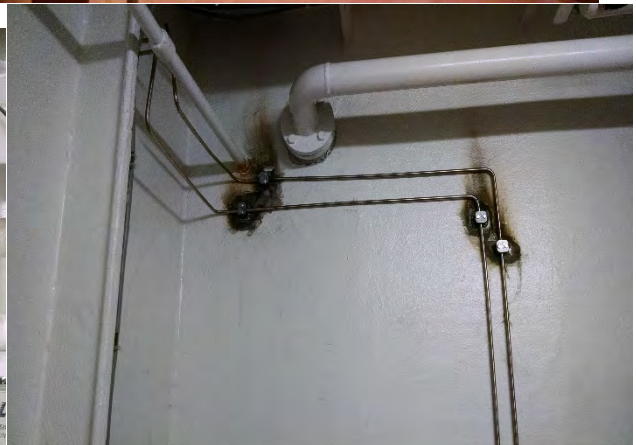
Duplex strainer installed in the stern thruster space for the strut and stern bearing cooling. Remote differential gauge installed in Machine shop, tubing run well. Paint needed to complete job. Sea Chest vent for Fire Pump extended through the main deck as per Configuration Change paint still needed.

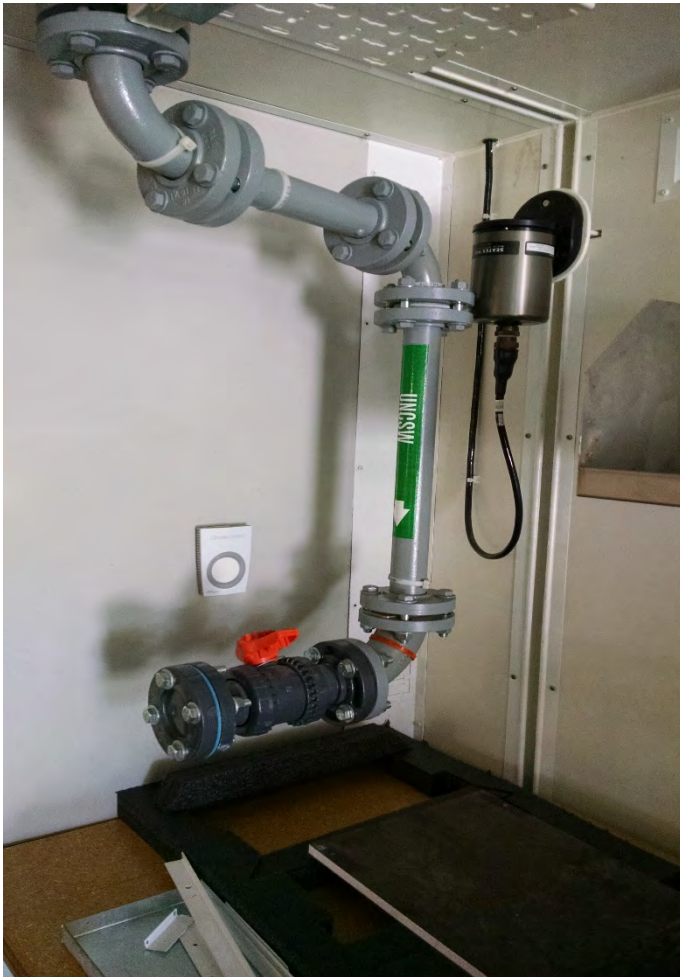
Both uncontaminated Sea Water piping taps in the main lab require hangers. Adam says he will install.  
Tom
